MOLTEN SALT TANK REPAIR

CLIENT - Cobra Thermosolar Plants
LOCATION - Tonopah, NV
EST. COMPLETION - October 2020

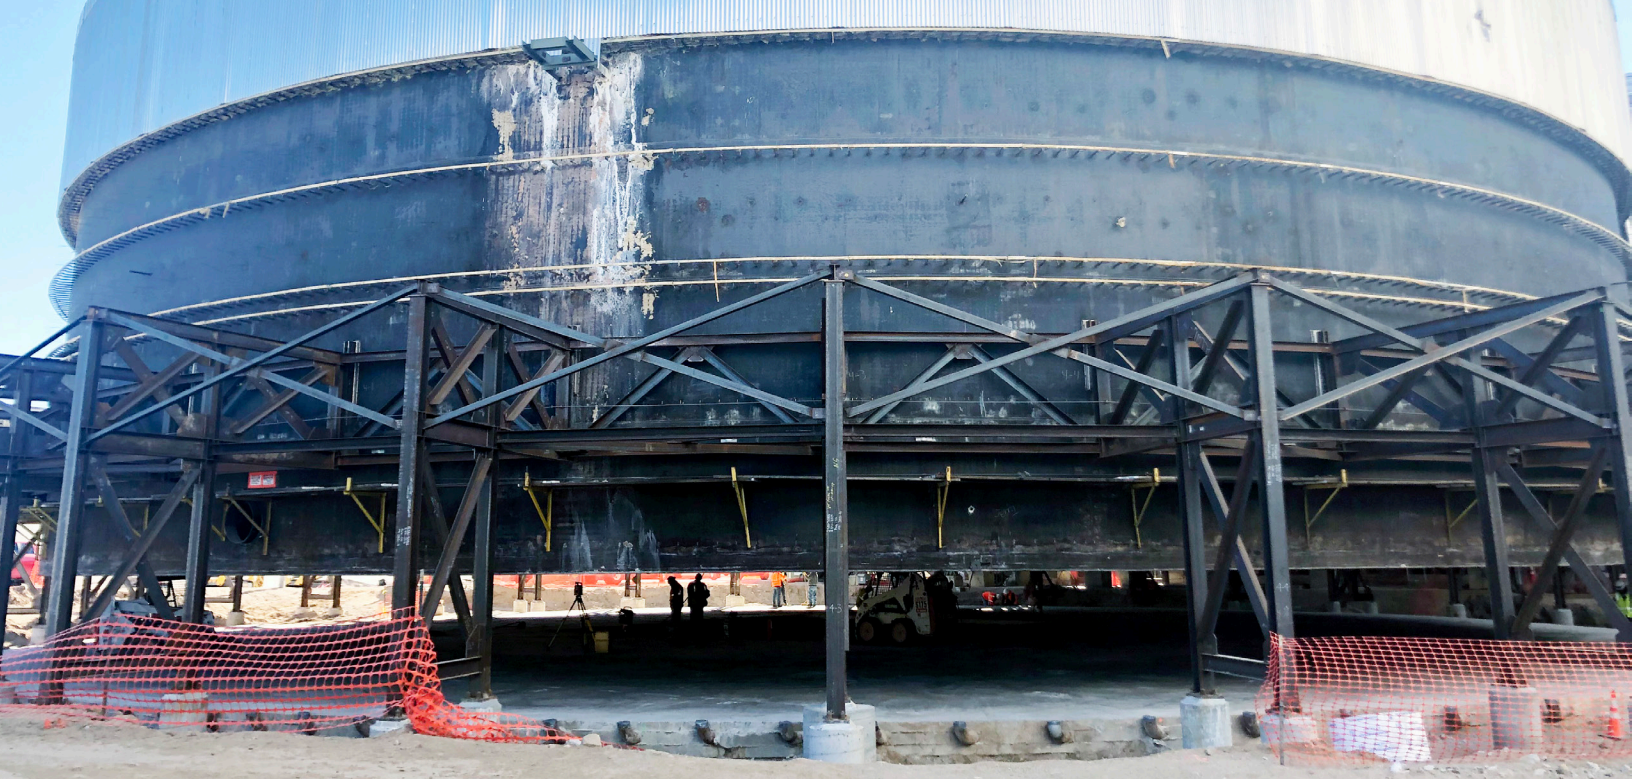
Matrix Service was contracted for the two-phase major tank repair of an existing molten salt tank. Phase one is to lift the entire tank above the ground to remove the tank bottom and foundation in preparation for total replacement (phase two). This first phase includes installing 32 jacking frames and 68 drill shaft piles into the ground up to 44' deep.

- Lifted 700-ton, 1 3/4" thick stainless steel molten salt tank (stores salt at 1,050 degrees)
- 200,000 lbs. of steel beams for jacking frame assembly
- 32 synchronized jacks system for lift
- At 700-tons, this is the most substantial Matrix tank lift to date
