MOLTEN SALT TANK REPAIR

CLIENT - Confidential
LOCATION - Southwest U.S.
COMPLETED - April 2021

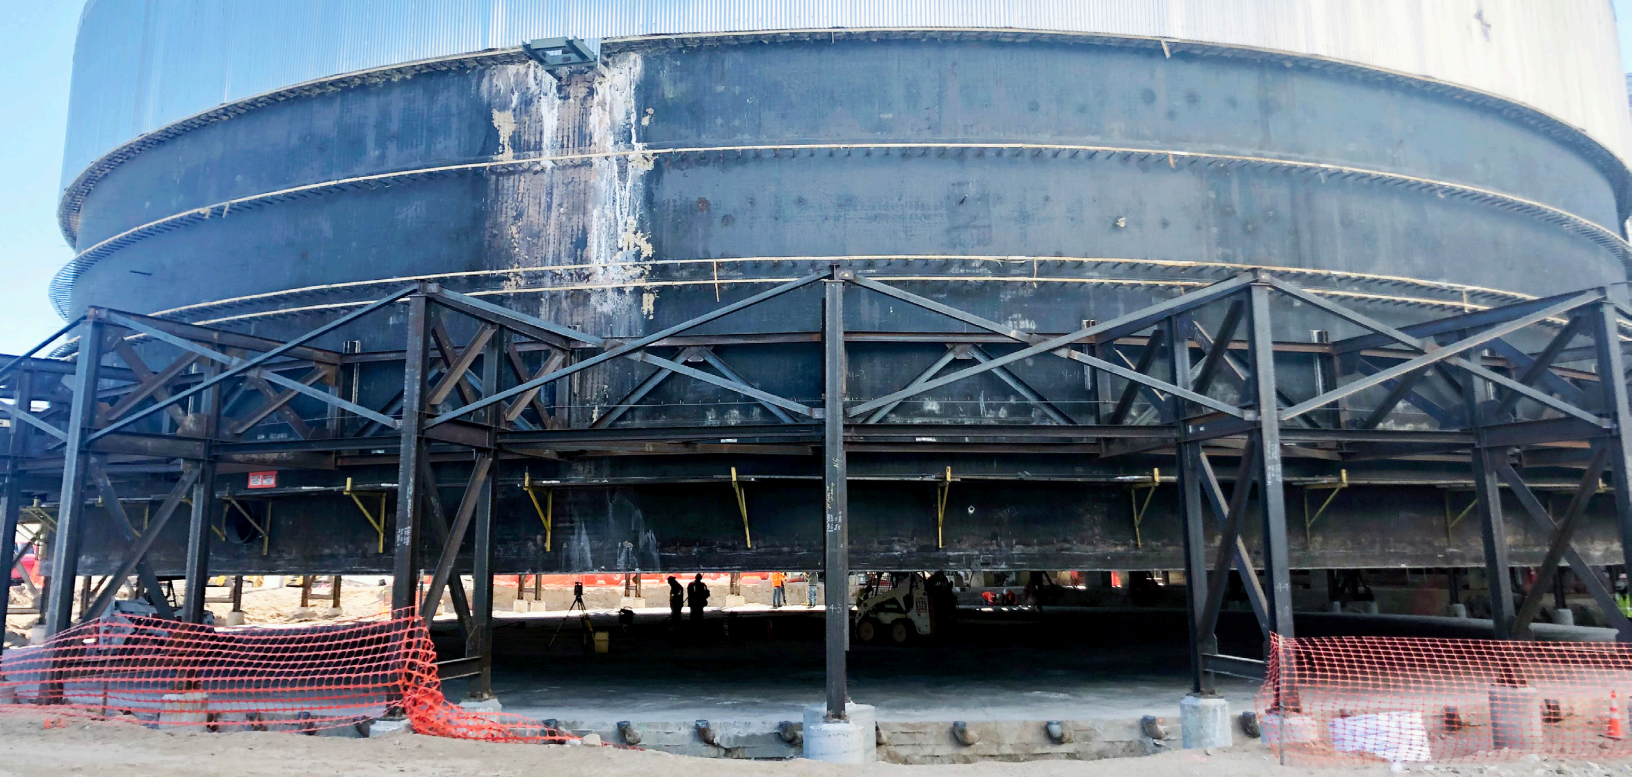
Matrix Service was contracted for the two-phase major tank repair of an existing molten salt tank. Phase one was to lift the entire tank above the ground to remove the tank bottom and foundation in preparation for total replacement (phase two). This first phase included installing 32 jacking frames and 68 drill shaft piles into the ground up to 44' deep.

- Lifted 700-ton, 1 3/4" thick stainless steel molten salt tank
- 200,000 lbs. of steel beams for jacking frame assembly
- 32 synchronized jacks system for lift
- At 700-tons, this is the most substantial Matrix tank lift to date
